MRWC Bacteria Monitoring Program

2017 Report: Millers & Otter Rivers

Prepared by:
Keith Davies
1/12/18

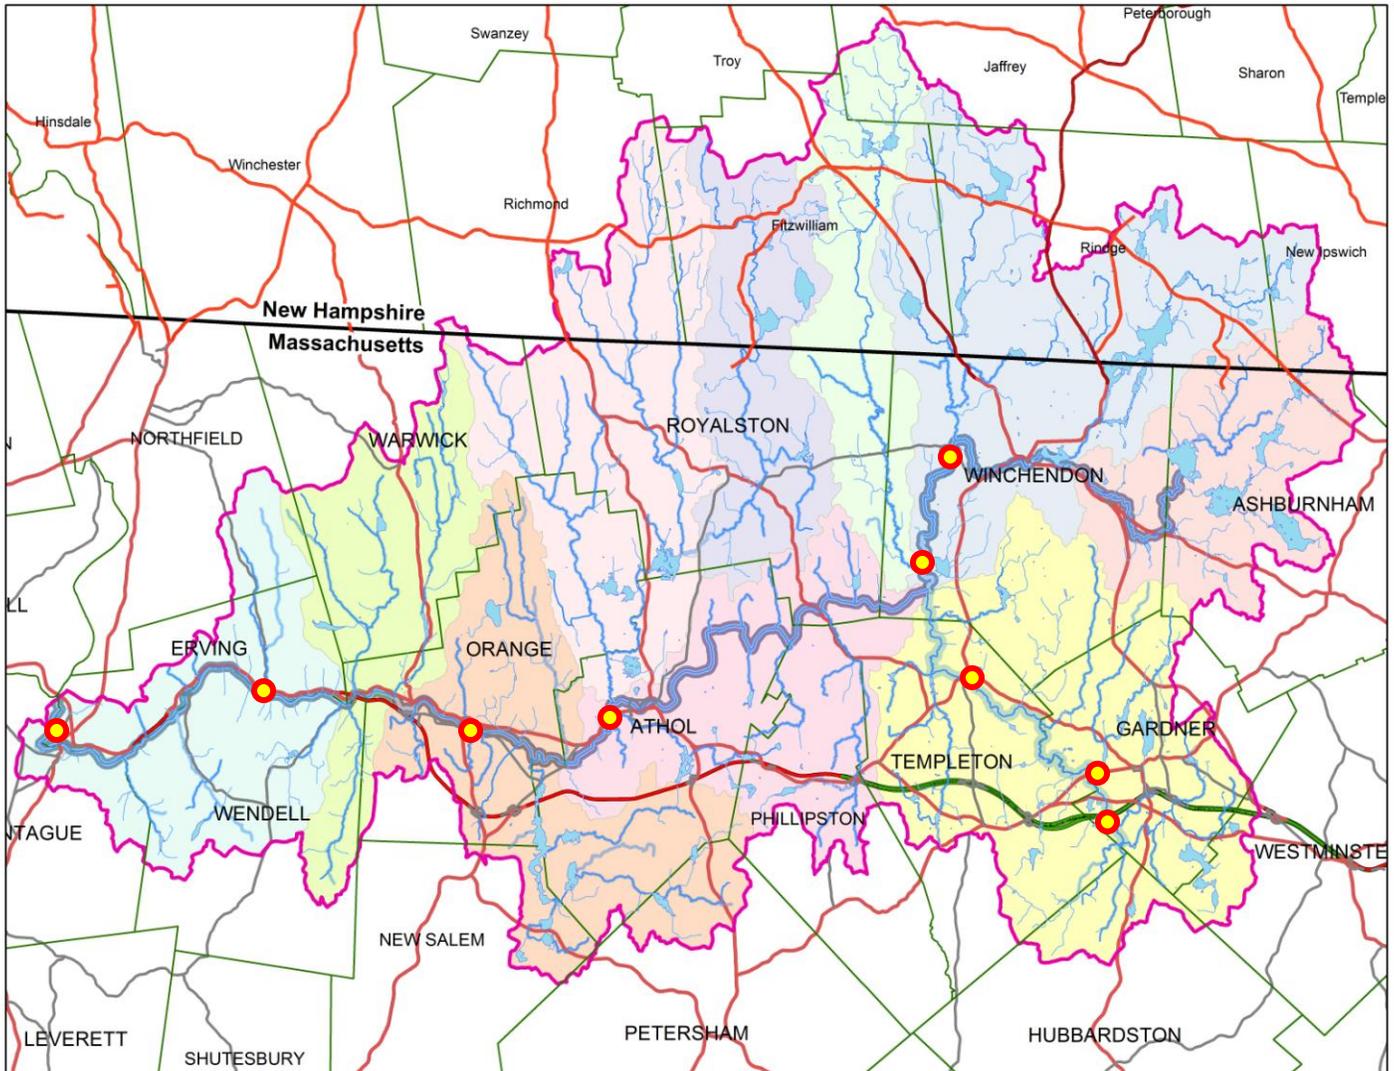
2017 Bacteria sample sites in the Millers Basin. ●

Dark blue river = Millers River, Light Blue river = Otter River
